As requested by YOU, we visited the site on DATE, from approximately TIME to TIME. The entire site visit was also observed by YOUR NAME. We reviewed the construction documents provided to us by YOU, both at the site and during the writing of this report, and have the following comments:

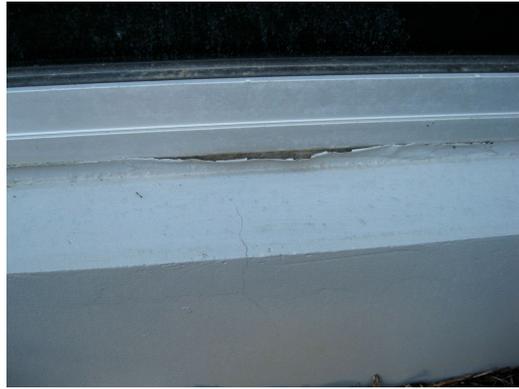
- a. It is noted that it appears that the exterior storefront window frames and glazing haven't been professionally cleaned since the building's completion, inasmuch as there is dirt, water-stained, lower glazing panes, and a small amount of excess window caulking on the glazing itself. The painter has painted over the storefront-to-concrete panel caulking and, in some cases, it has started to peel and separate from the caulking. **(See Photo #1 on page 2).**

1. Typical picture of paint over storefront-to-panel caulking that is peeling off caulking at exterior windows.

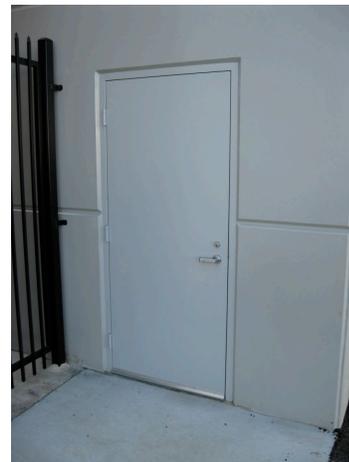
- b. It is suggested that the north west hollow-metal exit door has a sheet metal overhead drip guard installed on the door header to prevent water from running down the tilt-up wall and into the top of the door itself. This eventually leads to interior door rusting if not installed. **(See Photo #2 hereon).**

2. N.W. hollow metal door should have sheet metal overhead drip guard added to prevent water damage to door.

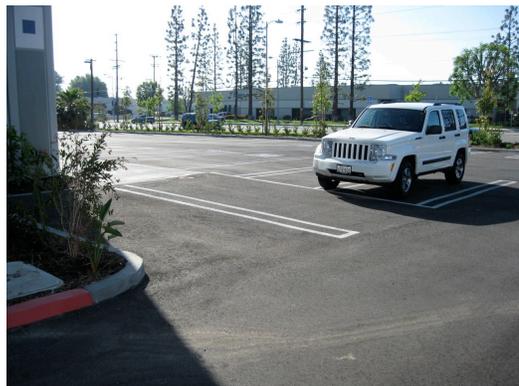
- c. Although not noted on the drawings, but seen in the field, check to see if the city requires “Compact” painted stencils at the compact stalls.
- d. Although not noted on the drawings, it is suggested that two or three 48” concrete parking bumpers be installed at the three compact stalls to the left of the building’s main entry that abut the two standard parking stalls. This will prevent a vehicle from hitting the car parked in the standard stall to the West of the building. **(See Photo #3, hereon).**

3. The 2-1/2 compact stalls to left of entry doors should have 4’ concrete parking bumpers installed to protect standard stalls.

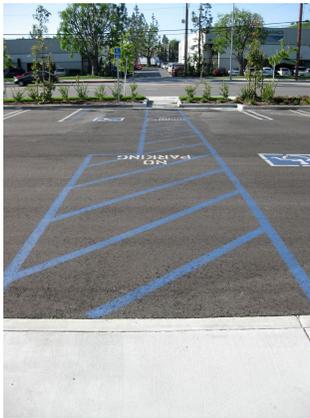
- f. **Photo #4, page 3** shows the striped path-of-travel for pedestrian foot traffic coming off Nordhoff Street into the property. If the building and site has received building department final inspection by the authoritative agency then, most likely, it has been approved without providing truncated domes prior to crossing a drive area.

4. Picture of striped Path-of-Travel from Nordhoff Street to building entry slab.

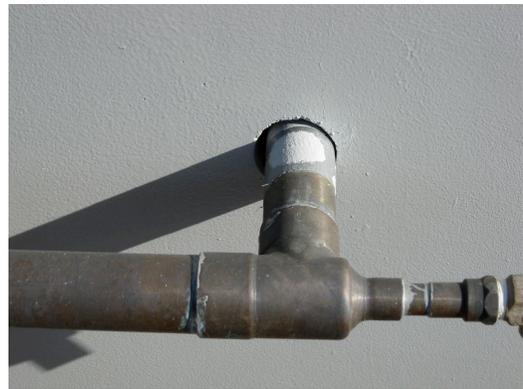
6. The main water service on the south side is missing caulking where it penetrates the building.

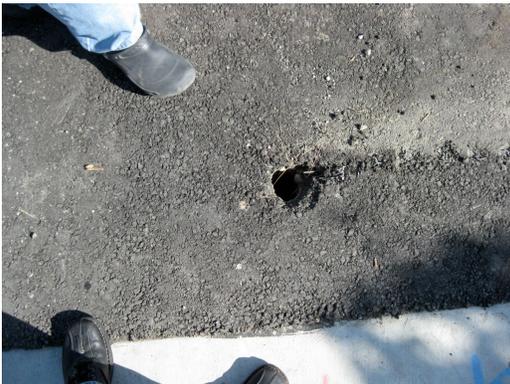
- e. There are two approximately 3” diameter holes in the asphalt driveway just north of the concrete entry approach where the temporary fencing and gates have been removed. Fill the holes and cap with asphalt and remove residual chain link protruding from the asphalt on the easterly side. **(See Photo #5, Page 3).**

5. One of two holes at left and right of top of entry drive approach that were left after removal of temporary gates/chain link fencing. Fill holes.

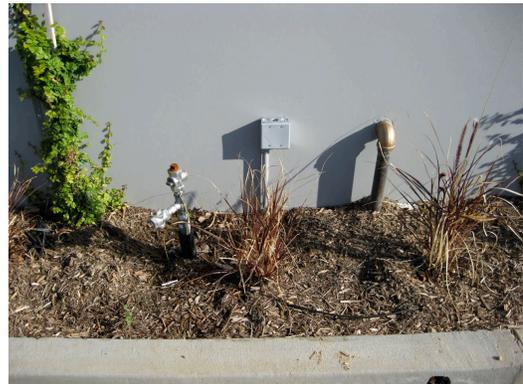
7. The fire sprinkler drain at the south elevation should be painted to match the building.

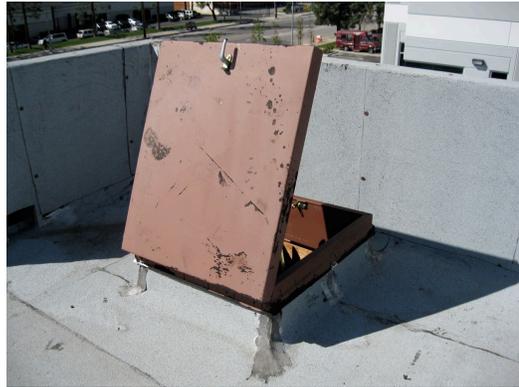
8. Roof hatch isn't painted and has roofing hot tar all over it.

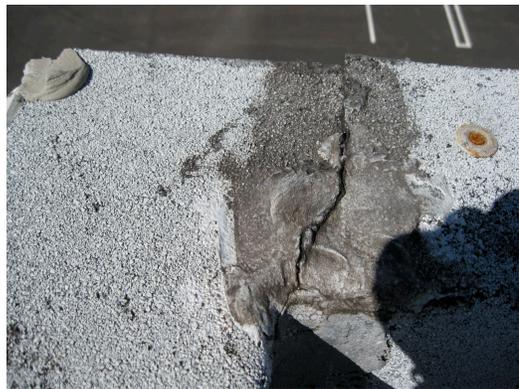
9. Ripping in parapet cap sheet at S.W. corner adjacent to roof hatch. Check if roof has existing warranty for such repairs.

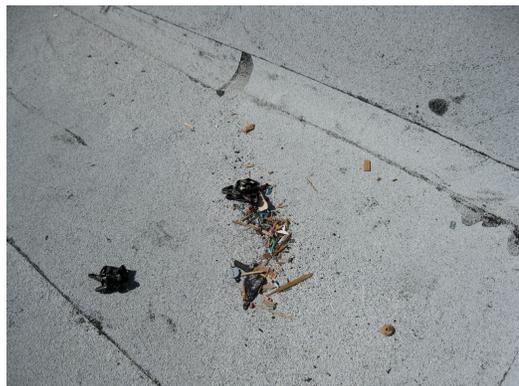
10. Typical of roof construction debris, wire cuttings, etc. left on roof after construction.

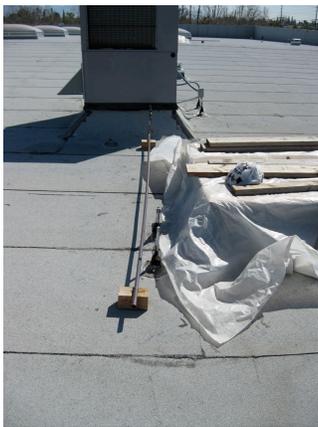
11. Copper condensate piping not properly run below roof through roof jack in photo #18 below to an approved receptor. West unit.

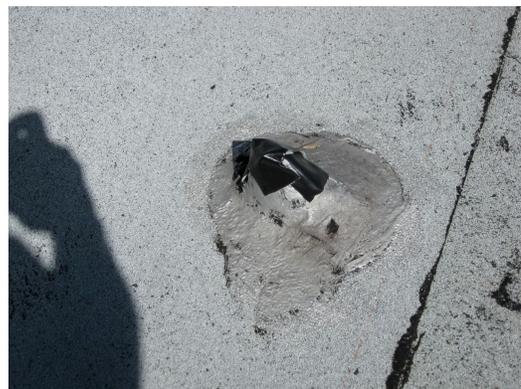
13. Typical photo of unused roof jack w/ black electrical tape over jack. Should be properly sealed with W.P. j-box/conduit thru roof.

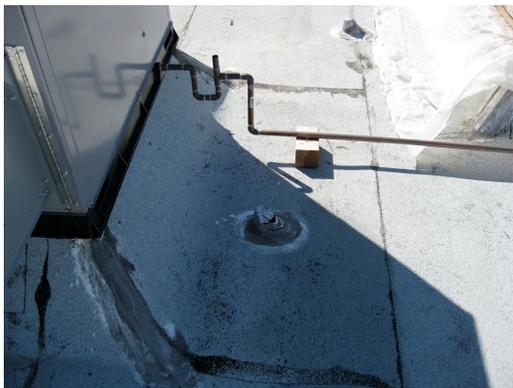
12. Roof jack w/ duct tape covering hole, typical of all non-used jacks. This was for condensate to run below roof. Not used.

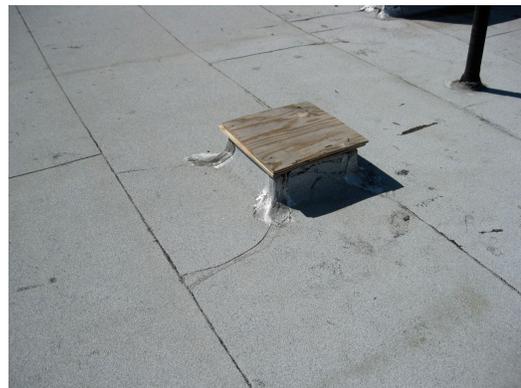
- f. The "future" roof exhaust curb over the West second floor area is again just covered in plywood. Fabricate and install a 24 ga. sheet metal cover per Detail 10/A-8 until an exhaust fan or tee flashing is installed to protect from the elements. (See **Photo #14, hereon**).

14. West roof future exhaust fan curb. Should have sheet metal cover made in lieu of plywood until exhaust fan is installed per 10/A-8 detail.

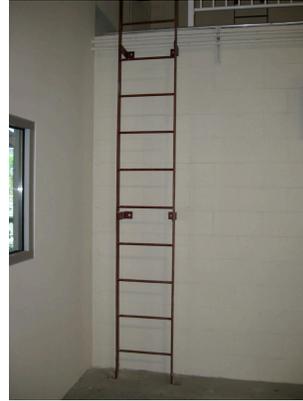
15. Upper transition and lower transition roof ladder assemblies not painted. Paint with semi-gloss paint to match interior walls.

- h. Both roof ladders haven’t been finish painted with semi-gloss paint to match the interior warehouse walls. **(See Photo #15, Page 6).**
- i. Although no fire rated separation is required between a B and S-2 occupancy, Title 24 Energy standards, since October of 2005, require that “conditioned” spaces such as offices have its insulating “envelope” moved up to the underside of the roof structure. This also requires that the office-to-warehouse walls separating the “conditioned” space be constructed full-height to the roof structure and insulated

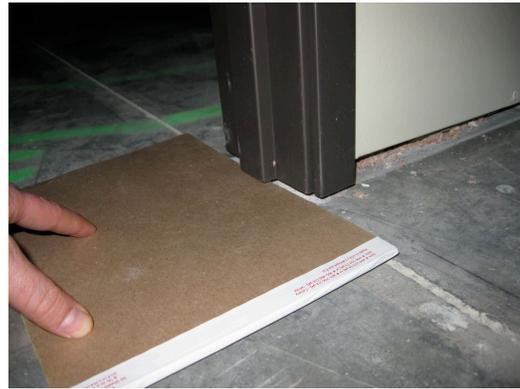
- a. Most if not all of the interior Timely door frames have been installed too far off the finished concrete slab for normal, direct glue-down carpet installation. This is also a similar case of all the first floor drywall. The drywall has gaps from finished concrete of anywhere from 3/4" to 1-1/2" near the office stairs. This won't allow for proper backing behind standard 4" high coved rubber base and, when hit with a vacuum cleaner, it will be knocked backward into the void. **(See Photos #16, 17, hereon).**

16. All interior 1st floor Timely door frames were installed too high off concrete floor for 1/4" flooring. Drywall also installed too high off

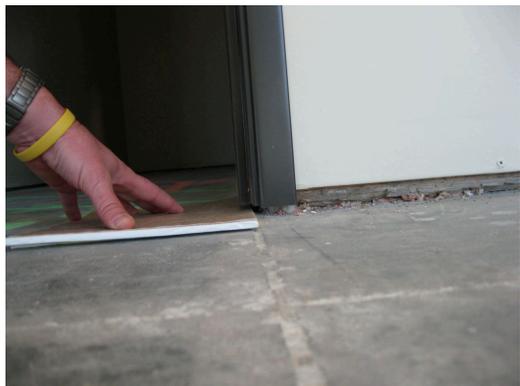
17. 3/4" to 1-1/2" gaps from concrete floor to drywall. When rubber base is installed it will get knocked in by vacuum w/o proper backing.

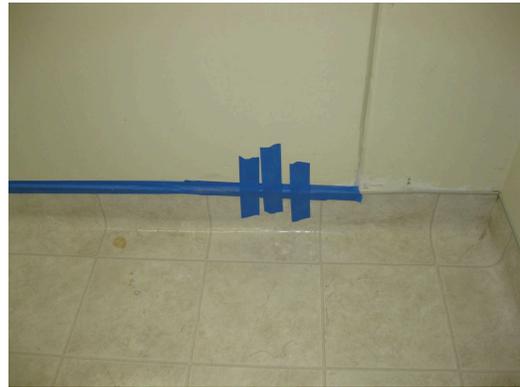
- b. The sheet vinyl self-coving in both warehouse restrooms and the office restrooms is coming loose from the wall. The women's warehouse restroom shows evidence of prior attempted repairs using painters tape to adhere the glued coving to the concrete tilt up wall. In some cases, painting needs to be touched up just above the self coving and construction dust from drilling and installing the grab bars and accessories is atop the metal trim. **(See photos #18, 19 on Page 7 and Photos #21, 22 on Page 8).**

18. Typical of warehouse restroom sheet vinyl self-coving coming loose from exterior south concrete wall in Women’s and Men’s restrooms.

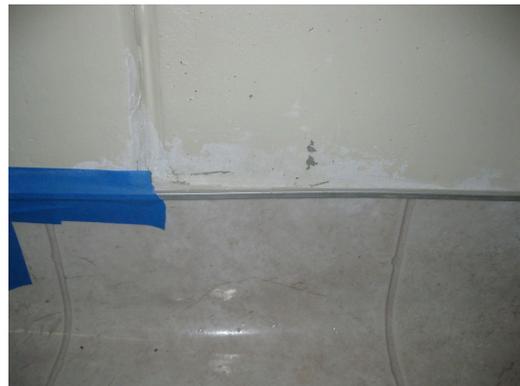
19. Missing proper paint finish above sheet vinyl in S.W. corner of Women’s warehouse restroom.

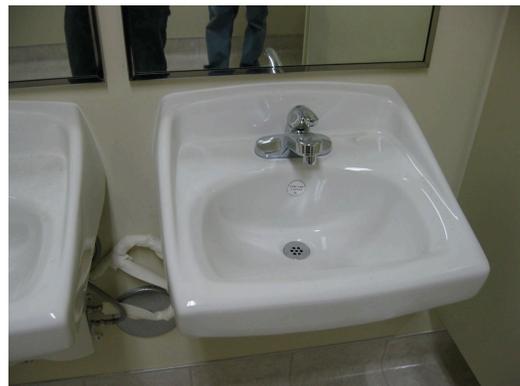
- c. All wall-hung restroom lavatory sinks are missing the soap dispensers called out on Note SD-1 on Details A,B,F/A-4. **(See Photo #20, Page 7)**
- d. The bathrooms in general need cleaning up of fixture labels on sinks and accessories and general mopping and wiping down.

20. Missing soap dispensers called for on plans at all wall-hung lavatories. All restroom fixtures are full of construction dust and labels.

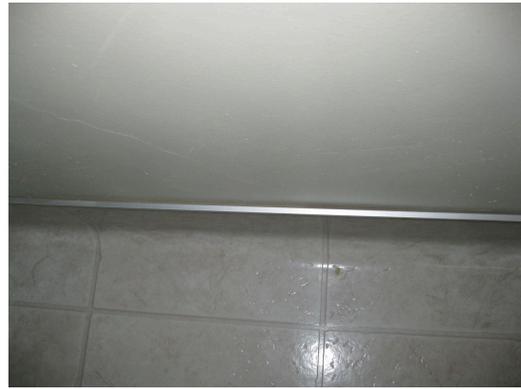
21. Another picture of sheet vinyl self-coving coming loose in Men's warehouse restroom.

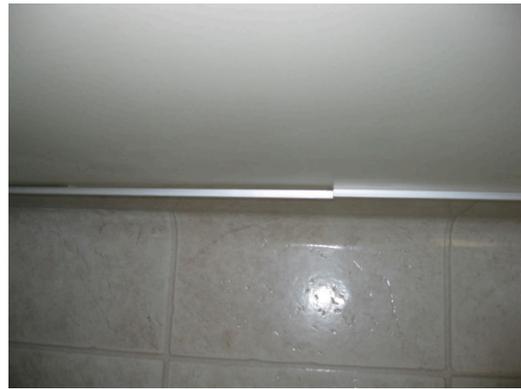
22. Sheet vinyl self-coving coming loose on West wall of women's warehouse restroom.

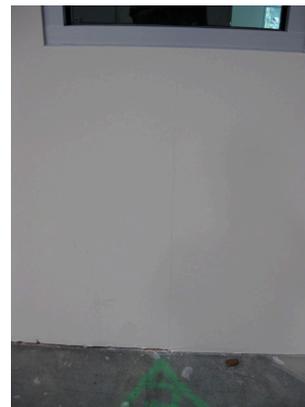
- g. There are vertical cracks in the warehouse side of the drywall under the lower office windows in two locations. The photo doesn’t clearly show the crack in such a small photo, but they exist. **(See Photo #23, Page 8).**

23. There are cracks in the warehouse side of the drywall running vertically centered under two of the warehouse-to-office windows.

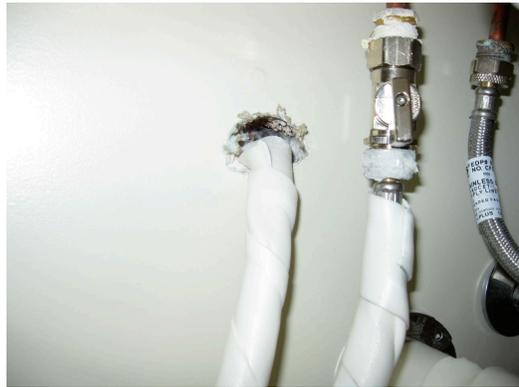
restrooms, each Insta-hot unit is feeding two wall hung lavatories. In the case of the single-use office restrooms, the plumber has opted to use stainless braided hoses from the Insta-hot in the northerly women’s restroom, and install a tee fitting and stainless braided hose through the wall into the men’s restroom faucet. This is against plumbing code and should have been hard piped within the wall to the other side and should be corrected. **(See Photo #24, Page 9)**

24. Women's office restroom Insta-hot stainless braided hose thru wall to Men's RR hot water doesn't meet Plumbing code. Repair.

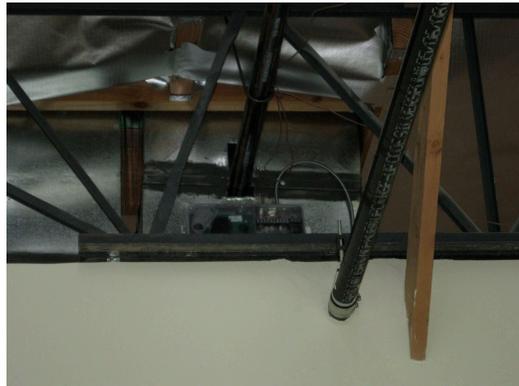
full-height as well. The current second floor condition at the office-to-warehouse wall at grid line #3 in the east to west direction is built under the Volcraft-type web roof truss. (See Photo # 23, Page 9). The opening in the wall isn't closing off the "conditioned" space to create the "envelope" as required by code and should be closed off and insulated with matching wall insulation. Secondly, without the Insulation Certification from the insulation installer stating the insulation manufacturer's name, material identification, and R-value per the Energy Requirements Note #2/AS-1, it is difficult to determine whether the finish "F-2" cap sheet has type 6 multi-layer foil within the sub purlin void space and meets the R-19 minimum requirements per the Title 24 ENV-1-C form/AS-3.2 and Envelope Mandatory Measure form ENV-MM, Item #118a also on Sheet AS-3.2. This will be a difficult and costly endeavor if it has to be done at the time of the second floor build-out when it should be in place now.

25. Typical gap above whse.-to-office wall. Don't have Title 24 envelope for conditioned office space w/ opening in wall to roof.
